V10-3868 | CYLINDER HEAD COVER

06D 103 469 N*

AIR CONTROL SYSTEMS | 11103

REPAIR SET, CYLINDER HEAD COVER

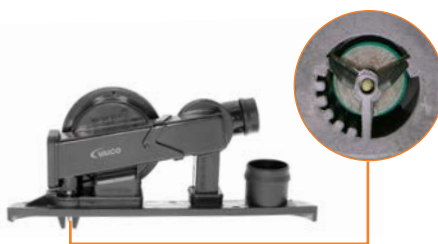
V10-9732

- **NOT** enough self-pressure
- additional throttle valve

VALVE, ENGINE BLOCK BREATHER

WITH THROTTLE VALVE

Engine Code	CDCC, CDLF, CDLG, CRZA, CDLA, CDLD
Audi	A3, A4, A6
Seat	Leon, Altea
VW	Golf V, Passat
Engine Type	Petrol
X-Ref	06F 129 101 N*

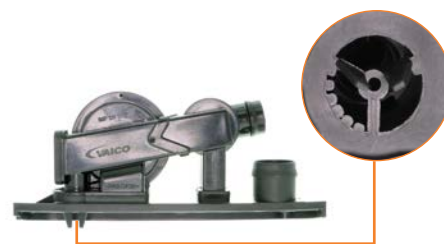
V10-9751

- enough self-pressure
- **NO** additional throttle valve

VALVE, ENGINE BLOCK BREATHER

WITHOUT THROTTLE VALVE

Engine Code	BPY, BWA, BPJ, BYIK
Audi	A3, A4, A6
Seat	Leon, Altea
VW	Golf V, Passat
Engine Type	Petrol
X-Ref	06F 129 101 P*

Cars with engine code **BPY, BWA, BPY, BXIK** have enough self pressure in the pressure room. For those cars it is absolutely necessary to use the oil separator **without throttle valve** (06F 129 101 P, V10-9751). Otherwise the pressure is additionally increased, which leads to **too much vacuum** and further issues to the breather system.

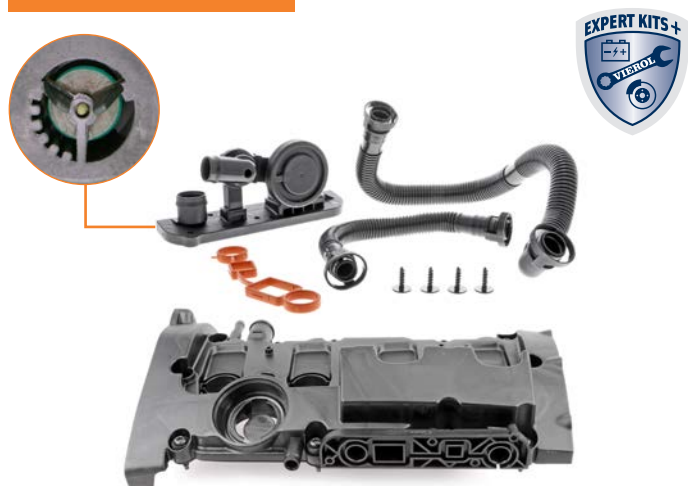
REPAIR SET, CYLINDER HEAD COVER

WITH THROTTLE VALVE

Engine Code	CDCC, CDLF, CDLG, CRZA, CDLA, CDLD		
Audi	A3, A4, A6		
Seat	Leon, Altea		
VW	Golf V, Passat		
Parts list	1x cylinder head cover	06D 103 469 N*	V10-3868
	1x oil separator	06F 129 101 N*	V10-9732
	1x gasket	06F 103 483 E*	V10-2559
	4x screws	N 104 128 04*	V10-3245
	1x hose	06F 103 235*	V10-2779
	1x hose	06F 103 221 E*	V10-0775
Engine Type	Petrol		
X-Ref	06D 103 469 N kit1*		V10-4149

- Please To avoid those problems, please always replace the cylinder head cover, the matched oil separator and hoses.

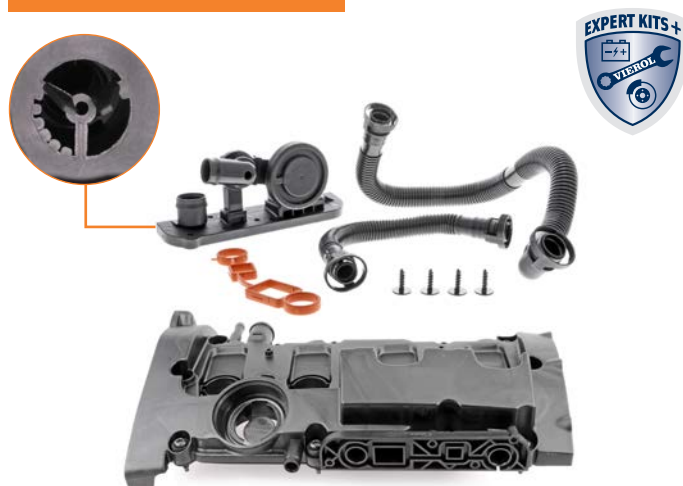
REPAIR SET, CYLINDER HEAD COVER

WITHOUT THROTTLE VALVE

Engine Code	BPY, BWA, BPJ, BYIK		
Audi	A3, A4, A6		
Seat	Leon, Altea		
VW	Golf V, Passat		
Parts list	1x cylinder head cover	06D 103 469 N*	V10-3868
	1x oil separator	06F 129 101 P*	V10-9751
	1x gasket	06F 103 483 E*	V10-2559
	4x screws	N 104 128 04*	V10-3245
	1x hose	06F 103 235*	V10-2779
	1x hose	06F 103 221 E*	V10-0775
	Engine Type	Petrol	
X-Ref	06D 103 469 N kit2*		V10-4152
